Sports Turf Solutions
Athletic Field Testing and Consulting Services

Re: Impact Test Results – Franklin Square Playground

Impact Test Data

Field Location: **Franklin Square Playground**
Date(s) of Test: **10/19/2011**

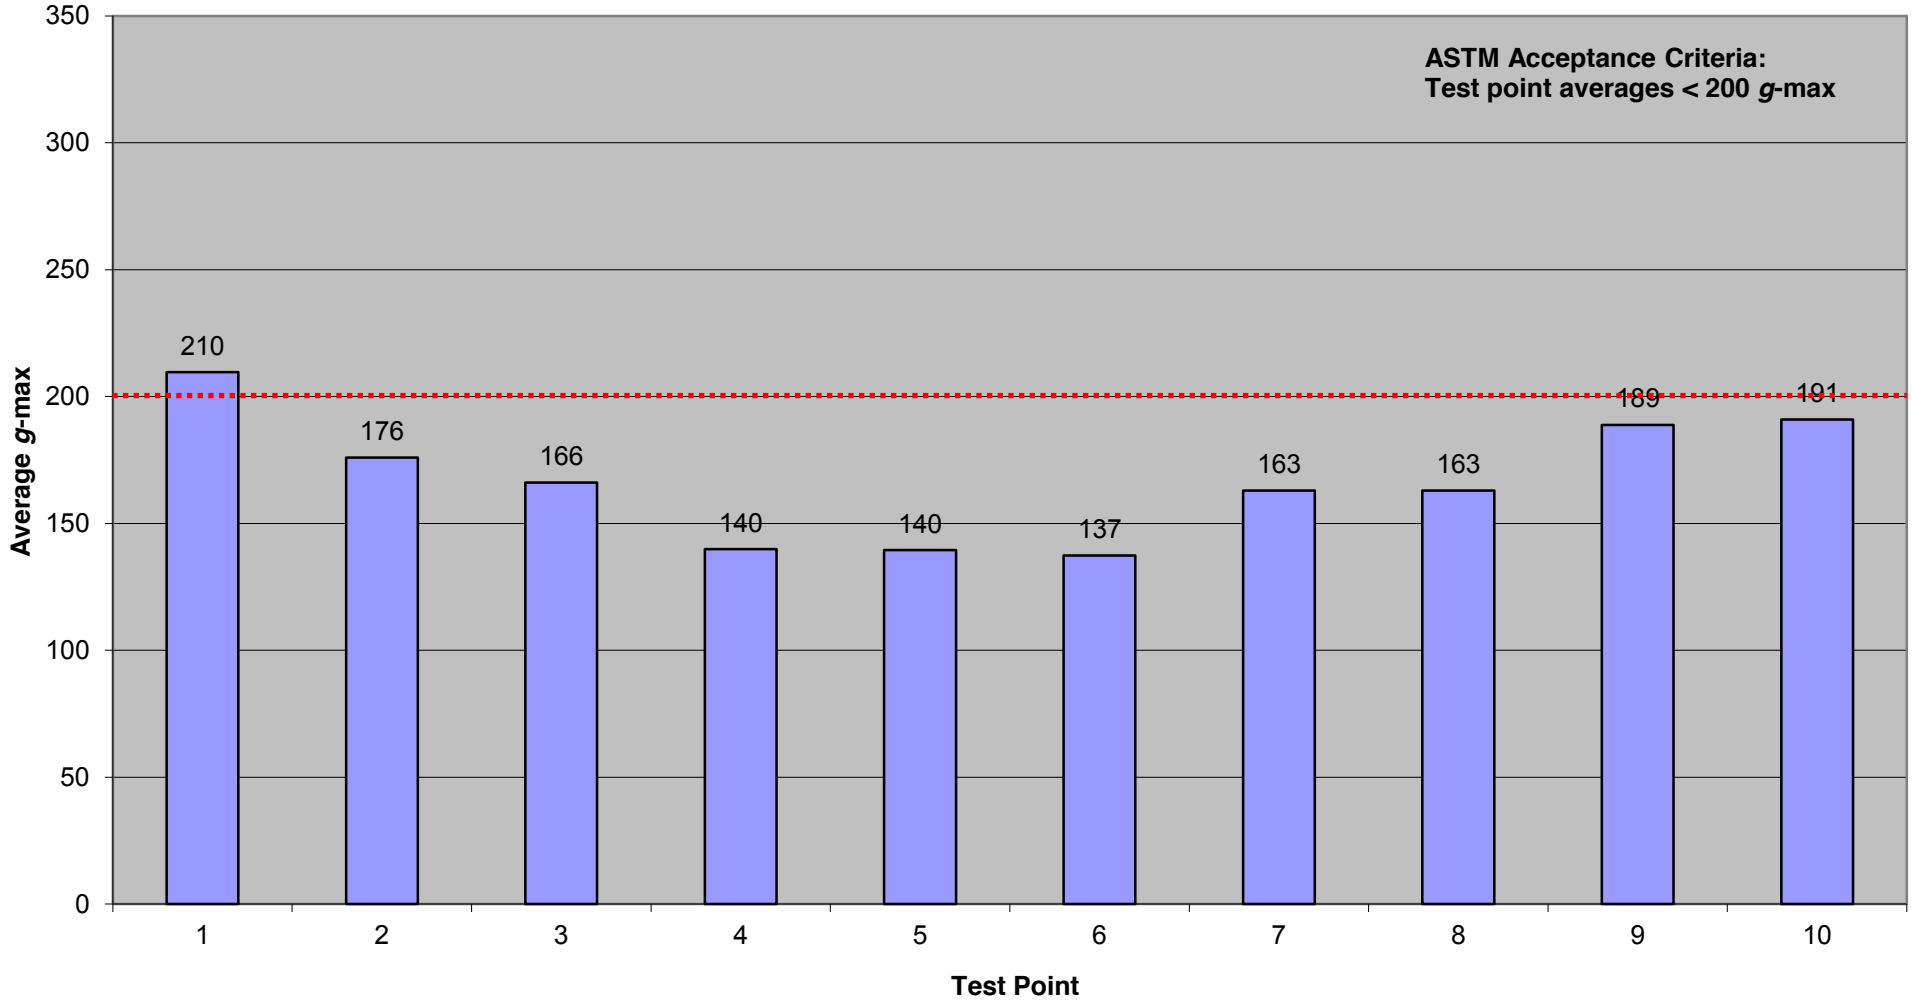
Average *g*-max Levels

The test results reported herein reflect the performance of the points tested, at the time of testing and at the temperatures reported. As recorded in the attached results, **test point #1failed to meet ASTM's requirement of <200 average *g*-max**, when tested in accordance with the above listed method and specification. (It should be noted that these results do not imply that an impact-related injury cannot occur if the surface system complies with ASTM's *g*-max requirement.)

Range of *g*-max averages:	
Highest average reading	210
Lowest average reading	137
Average of the averages	167

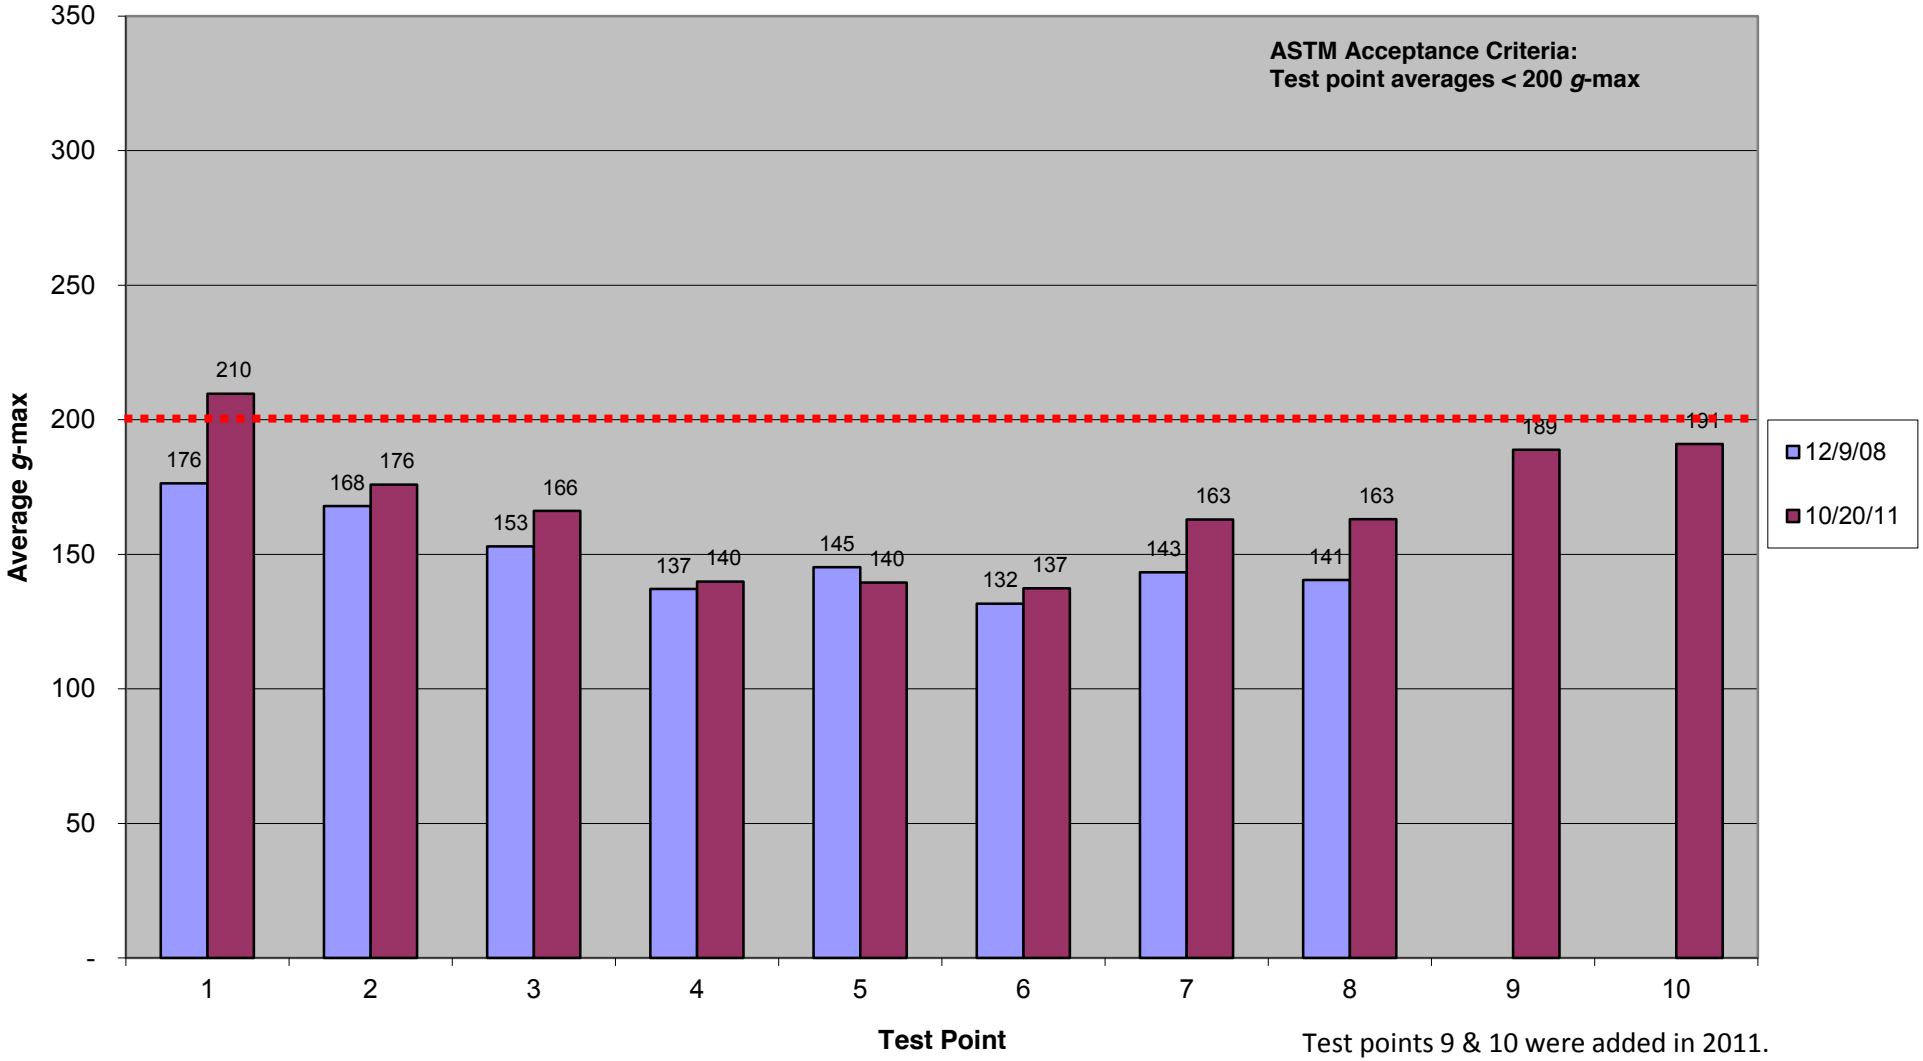
Franklin Square Playground - Soccer Field
Comparison of Past and Present g-max Values

Test points 9 & 10 were added in 2011.

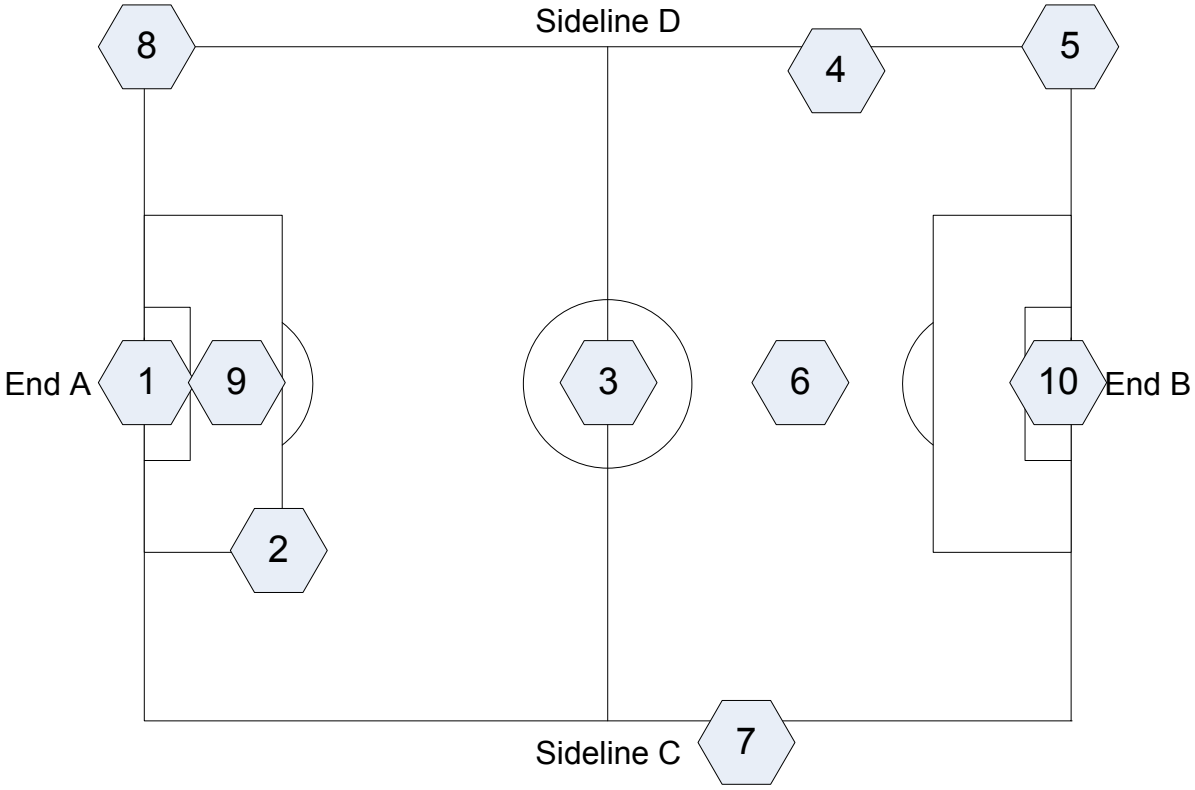
Test Point Reference Guide

Point 1 – Goal line, end A, center of field
Point 2 – Corner of penalty box between end A and mid-field line, closest to sideline C
Point 3 – Mid-field line, center of field
Point 4 – Half way between mid-field line and end B, 3 ft into the field from sideline D
Point 5 – Corner of the field at end B and sideline D
Point 6 – Half way between mid-field line and penalty box at end B, center of field
Point 7 – 50' from mid-field line to end B, 3' outside sideline C
Point 8 – Corner of the field at end A and sideline D
Point 9 – 1' from penalty kick spot to mid-field line, end A, center of field
Point 10 - 3' from goal line to mid-field line, end B, center of field
