Sports Turf Solutions
Athletic Field Testing and Consulting Services

Re: Impact Test Results – Youngblood Coleman Playground

Field Location: **Youngblood Coleman Playground**
Date(s) of Test: **10/19/2011**

Youngblood Coleman Playground - Soccer Field

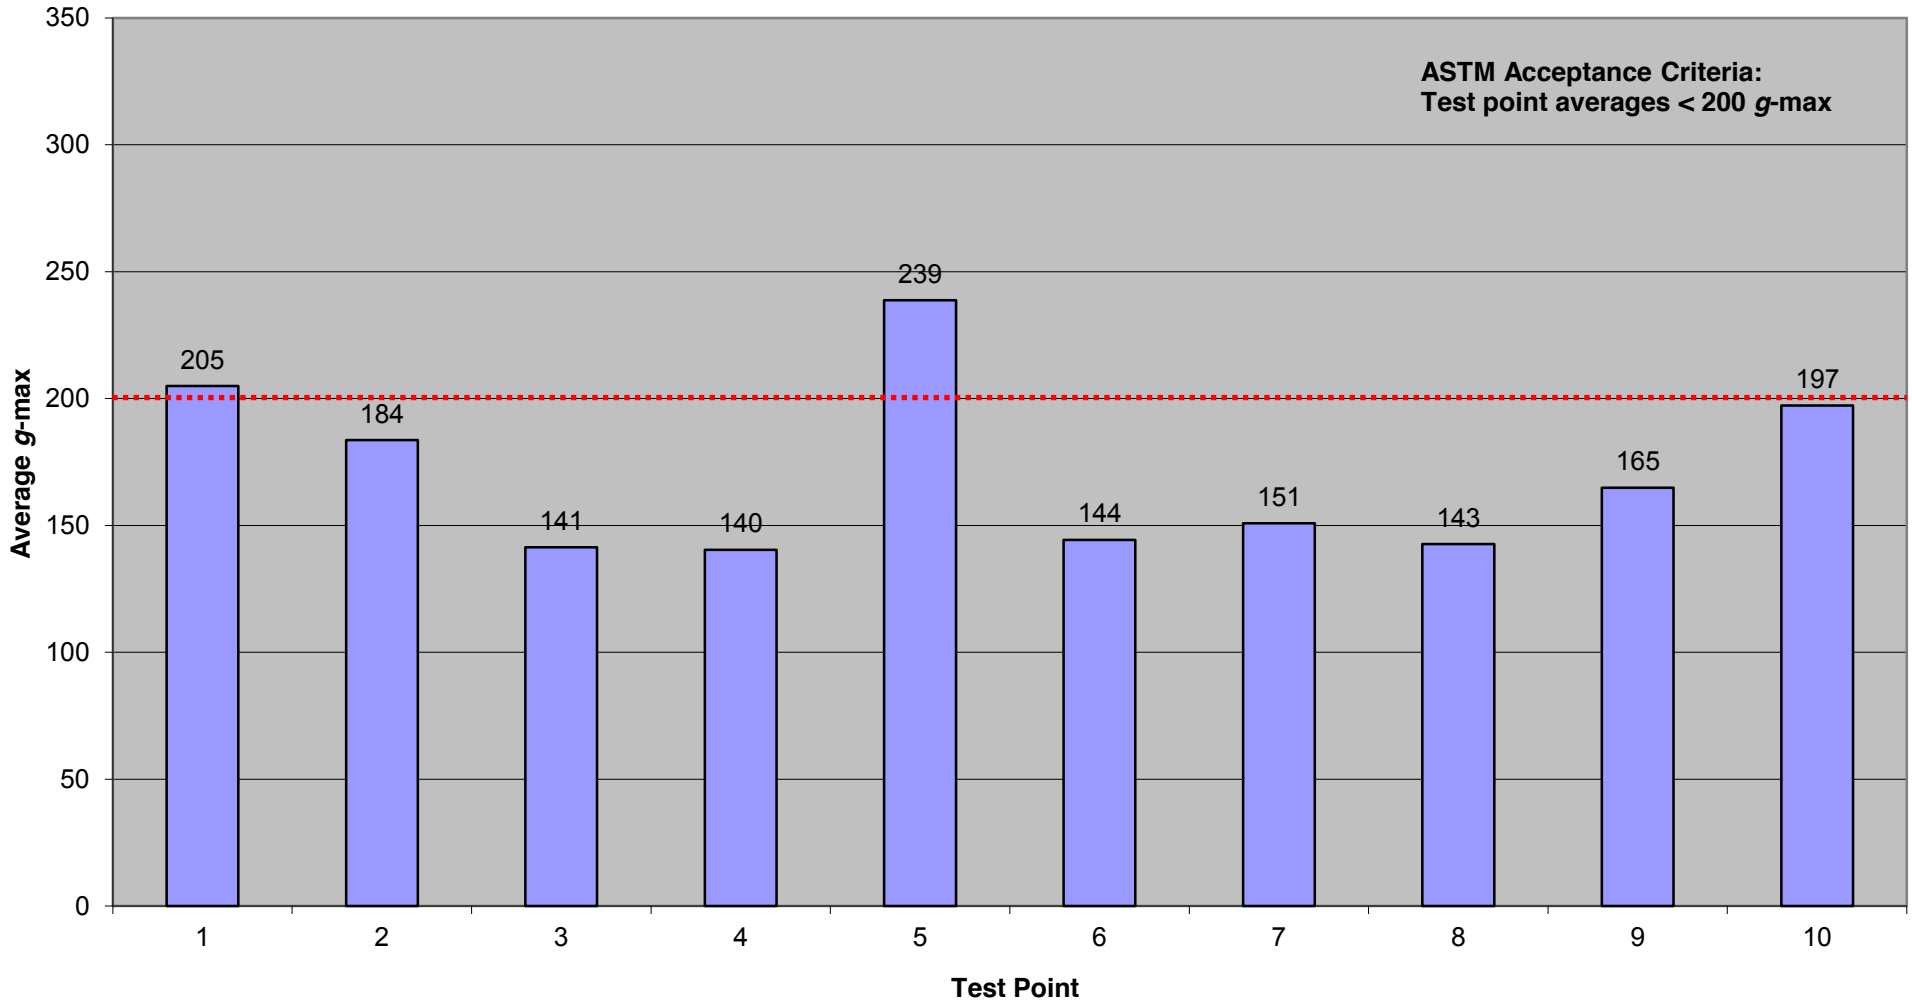
Average *g*-max Levels

The test results reported herein reflect the performance of the points tested, at the time of testing and at the temperatures reported. As recorded in the attached results, **test points #1and #5 failed to meet ASTM's requirement of <200 average *g*-max**, when tested in accordance with the above listed method and specification. (It should be noted that these results do not imply that an impact-related injury cannot occur if the surface system complies with ASTM's *g*-max requirement.)

Range of *g*-max averages:	
Highest average reading	239
Lowest average reading	140
Average of the averages	171

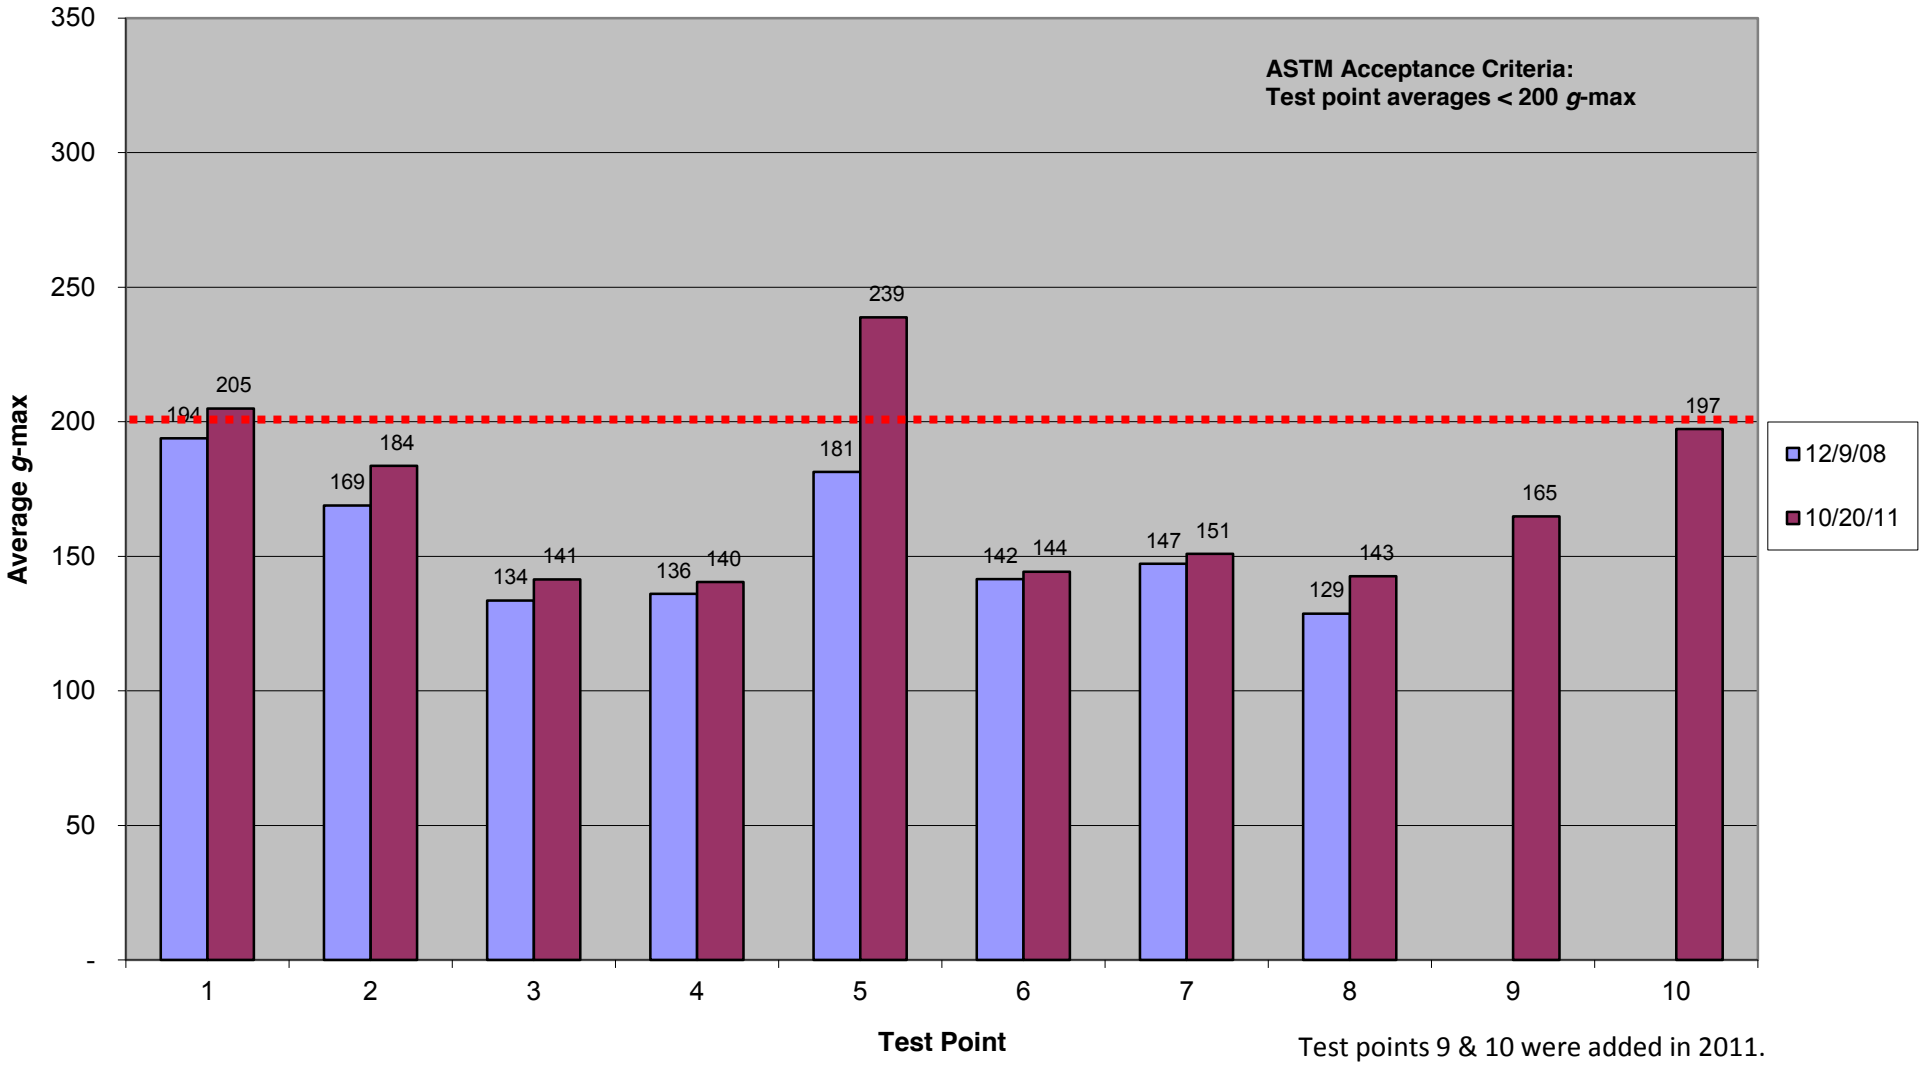
Youngblood Coleman Playground - Soccer Field
Comparison of Past and Present g-max Values

Test points 9 & 10 were added in 2011.

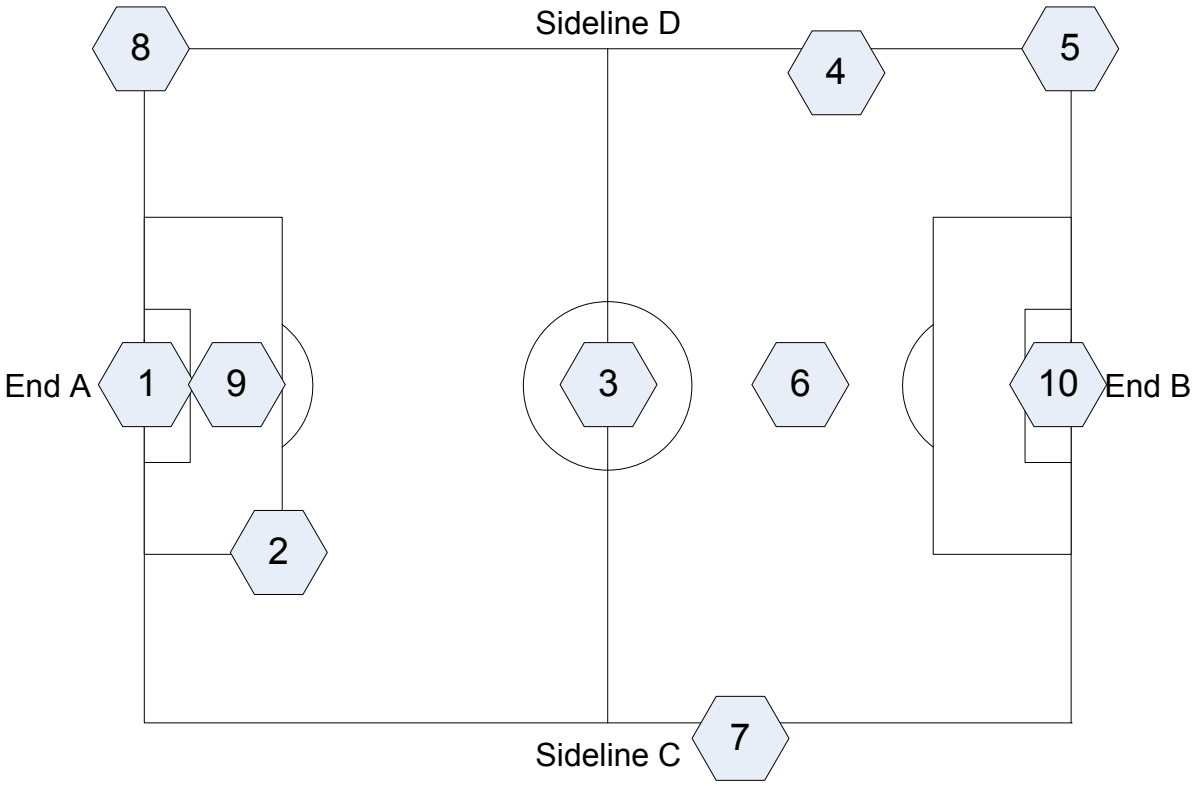
Test Point Reference Guide

Point 1 – Goal line, end A, center of field
Point 2 – Corner of penalty box between end A and mid-field line, closest to sideline C
Point 3 – Mid-field line, center of field
Point 4 – Half way between mid-field line and end B, 3 ft into the field from sideline D
Point 5 – Corner of the field at end B and sideline D
Point 6 – Half way between mid-field line and penalty box at end B, center of field
Point 7 – 30' from mid-field line to end B, 3' outside sideline C
Point 8 – Corner of the field at end A and sideline D
Point 9 – 1' from penalty kick line to mid-field line, end A, center of field
Point 10 – 3' from goal line to mid-field line, end B, center of field
